# Dam Safety- Fact Sheet

Montana Watercourse and Montana Department of Natural Resources and Conservation  
Water Resources Division

## Basic Dam Layout and Nomenclature

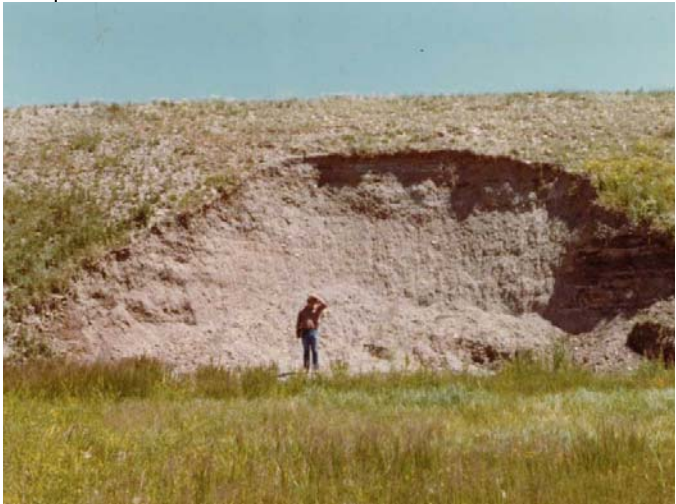
Seepage has severely damaged this embankment.

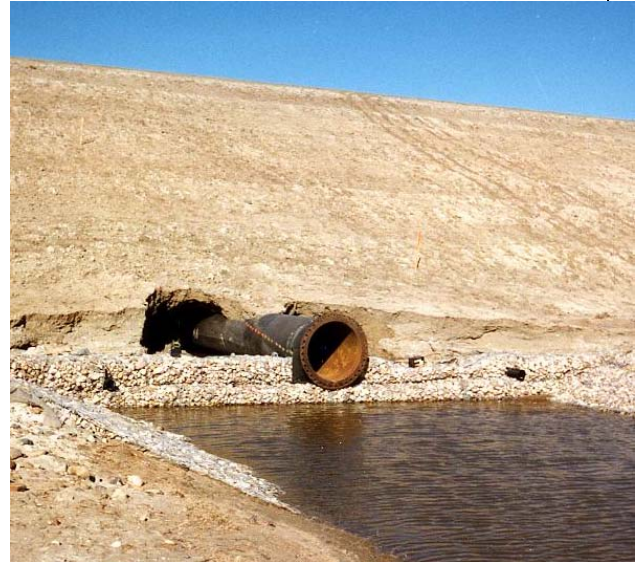
The area around the metal conduit has been eroded away by seepage along the pipe.

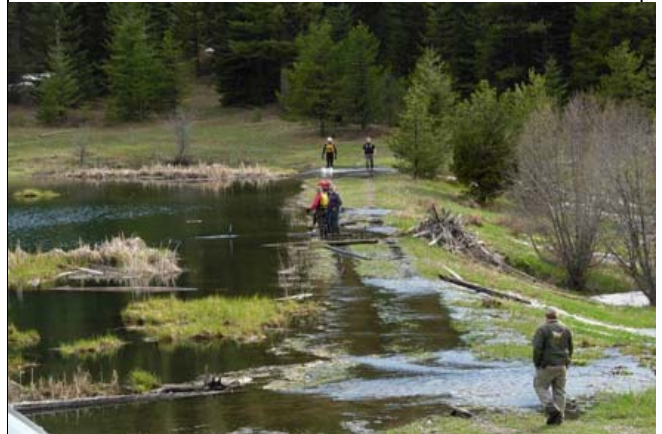
Overtopping failures result from the erosive action of water on the embankment. Erosion

from overtopping is due to uncontrolled flow of water over, around, and adjacent to the dam.

Earth embankments are not designed to be overtopped and therefore are particularly susceptible to erosion. Once erosion has begun during overtopping, it is almost impossible to stop. A well vegetated earth embankment may withstand limited overtopping if its crest is level and water flows over the crest and down the face as an evenly distributed sheet without becoming concentrated. The owner should closely monitor the reservoir pool level during severe storms. The primary defense against overtopping is properly designed and maintained spillways.

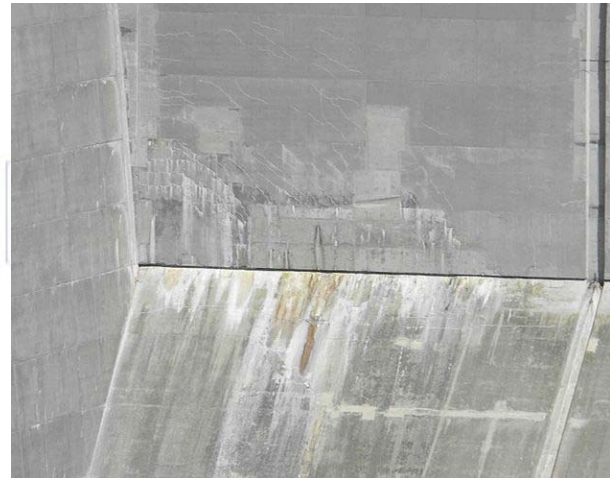
Efflorescence on a concrete face of a dam.

A white, crystallized substance, known as efflorescence, may sometimes be noted on concrete surfaces, especially spillway sidewalls. It is usually noted near hairline or thin cracks. Efflorescence is formed by water seeping through the pores or thin cracks in the concrete. When the water evaporates, it usually leaves behind a thin white film. This film is the minerals that have been leached from the soil, fill, or concrete as water passes through them. Efflorescence is typically not a structural problem unless it contains sulphates or other salts that can deteriorate concrete.

Efflorescence should be monitored because it can indicate the amount of seepage finding its way through thin cracks in the concrete and can signal areas where problems (i.e. inadequate drainage behind the wall or deterioration of concrete) could develop.

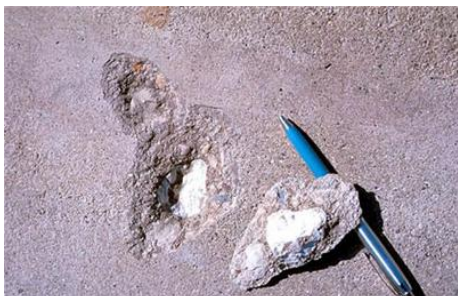
Popouts are caused by the freeze thaw cycle.

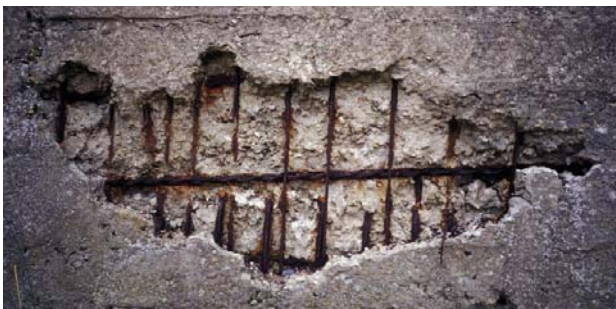
Spalling exposes metal reinforcement to corrosion.

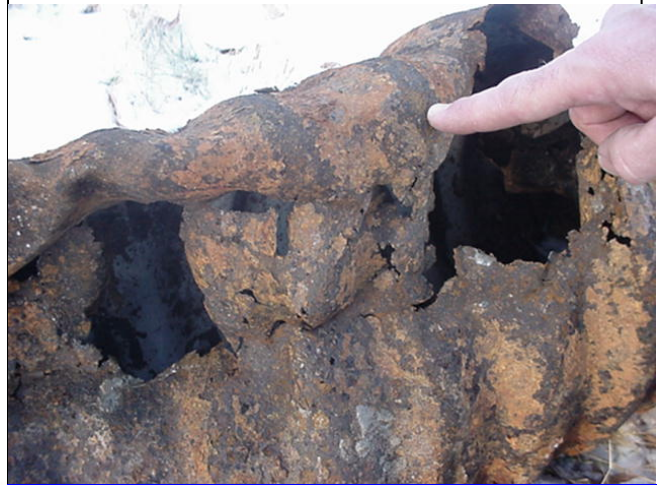
Severely damaged corrugated metal pipe, due to corrosion.

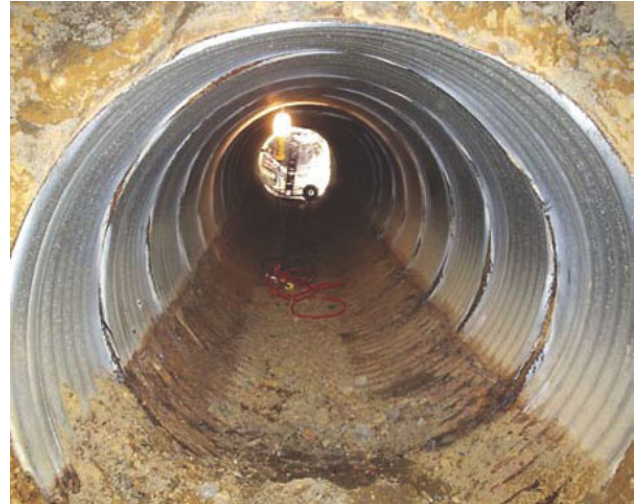
Aging metal culvert, with bulging seams and some corrosion on the bottom of the pipe.

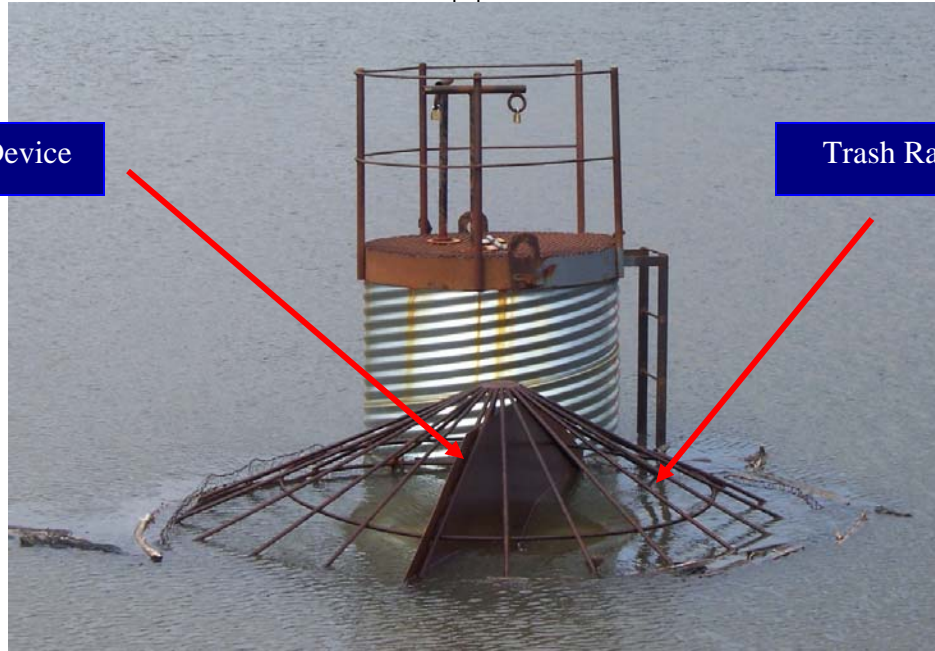
Anti-vortex Device

An anti-vortex device can easily be incorporated into most trashrack designs. A common anti-vortex device is a flat metal plate which is placed on edge and attached to the inlet of the spillway.

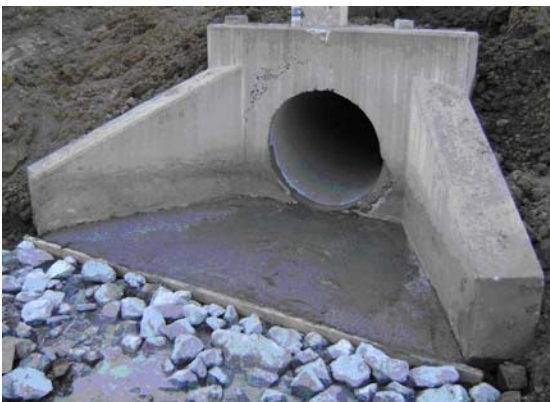
Concrete Headwall

A headwall/endwall located at or close to the end of the discharge conduit will provide support and reduce the potential for undermining. A headwall/endwall is typically constructed of concrete, and it should be founded on bedrock or have an adequate foundation footing to provide support for stability. A headwall/endwall can become displaced if it is not adequately designed and is subject to undermining. Displacement of the headwall/endwall can lead to separation of the spillway conduit at the joints which could affect the integrity of the spillway conduit. If a concrete structure develops the structural defects, or if the discharge spillway conduit does not have a headwall/endwall, then a registered professional engineer should be contacted to evaluate the stability of the outlet.

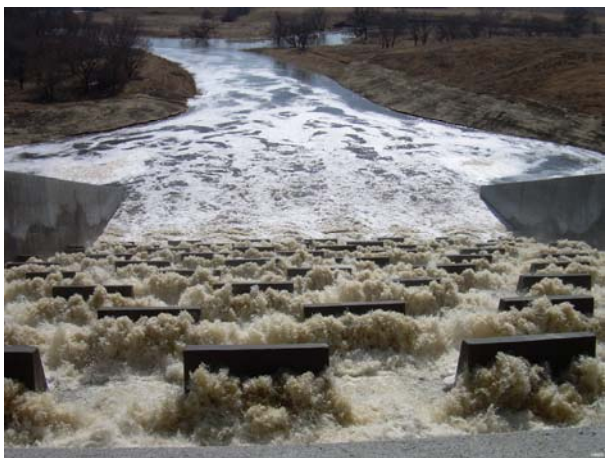
Baffled Chute

**Baffled Chute**

Baffled chutes require no initial tailwater to be effective and are located downstream of the control section. Multiple rows of baffle piers on the chute prevent excessive acceleration of the flow and prevent the damage that occurs from a high discharge velocity. A portion of the baffled chute usually extends below the streambed elevation to prevent undermining of the chute. If any of the severe problems associated with concrete that are referenced in the opening paragraphs are observed, a registered professional engineer should be contacted to evaluate the stability of the outlet.

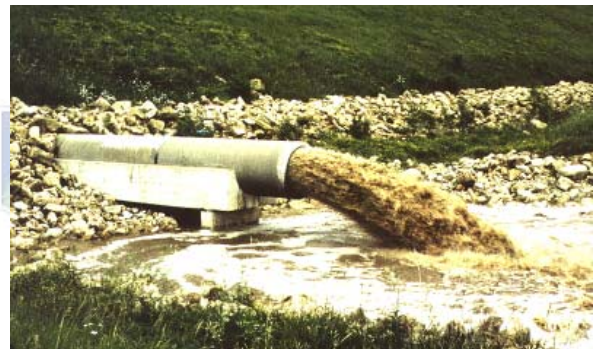
Plunge Basin

**Plunge Pool**

A plunge pool dissipates energy as the discharge flows into the plunge pool. Plunge pools are commonly lined with rock riprap or other material to prevent excessive erosion of the pool area. Discharge from the plunge pool should be at the natural streambed elevation. Typical problems may include movement of the riprap, loss of fines from the bedding material and scour beyond the riprap and lining. If scour beneath the outlet conduit develops, the conduit will be left unsupported and separation of the conduit joints and undermining may occur. Separation of the conduit joints and undermining may lead to failure of the spillway and ultimately the dam. A registered professional engineer should be contacted to ensure that the plunge pool is designed properly.

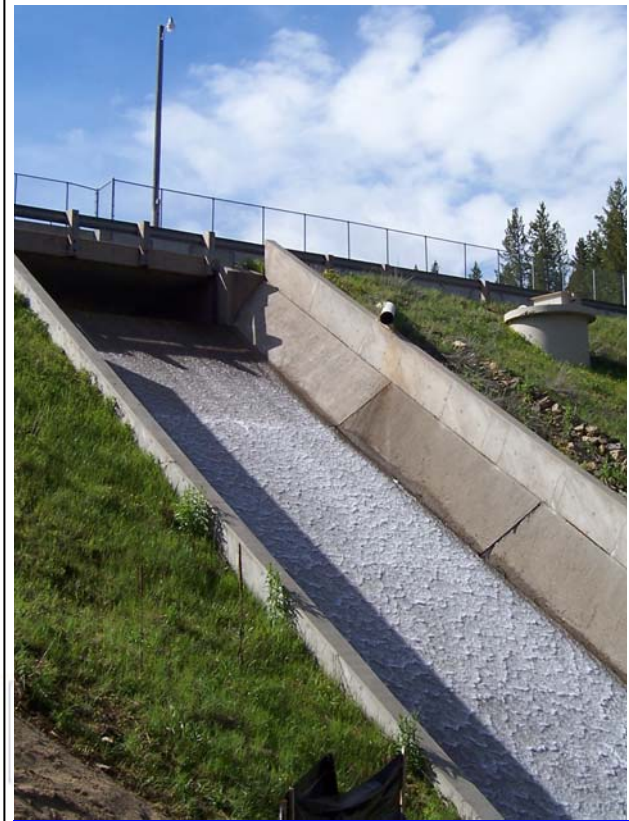
Weep holes, relief drains and underdrains must be included with the concrete chute to relieve excessive water pressure or infiltration from behind the walls and floor. The drainage system for the chute should consist of correctly placed and sized drainage holes, perforated pipes, and filter and bedding materials, such as sand and gravel. Seepage can occur through the dam, along the contact between the embankment and the concrete chute, or through open joints and cracks. Uncontrolled seepage flow along the structure can erode the underlying fill material (undermining) which may cause cracking or buckling of the slabs. Excessive pressure behind the walls and floor of the chute can cause cracking and heaving of the concrete. The freeze-thaw cycle can increase the amount of stress and strain on the concrete and can also cause heaving, cracking and additional serious damage to the structure. Weep holes, relief drains, and underdrainage for a concrete chute spillway should be designed by a registered professional engineer.

Concrete spillway on embankment of dam.

A cutoff wall should be placed at the entrance to the concrete chute to prevent the flow approaching and entering the chute from flowing beneath and undermining the floor slabs. Undermining of the chute can cause cracking and collapse of the slabs as the underlying material is eroded away. In addition, a cutoff wall is necessary at the downstream end of the chute in order to prevent undermining by flows exiting the chute and entering the downstream channel. The cutoff wall or endwall should be founded on bedrock or have adequate support to provide stability and prevent undermining of the wall itself. Refer to Outlet Erosion Control Fact Sheet #18 for further discussion on erosion control.

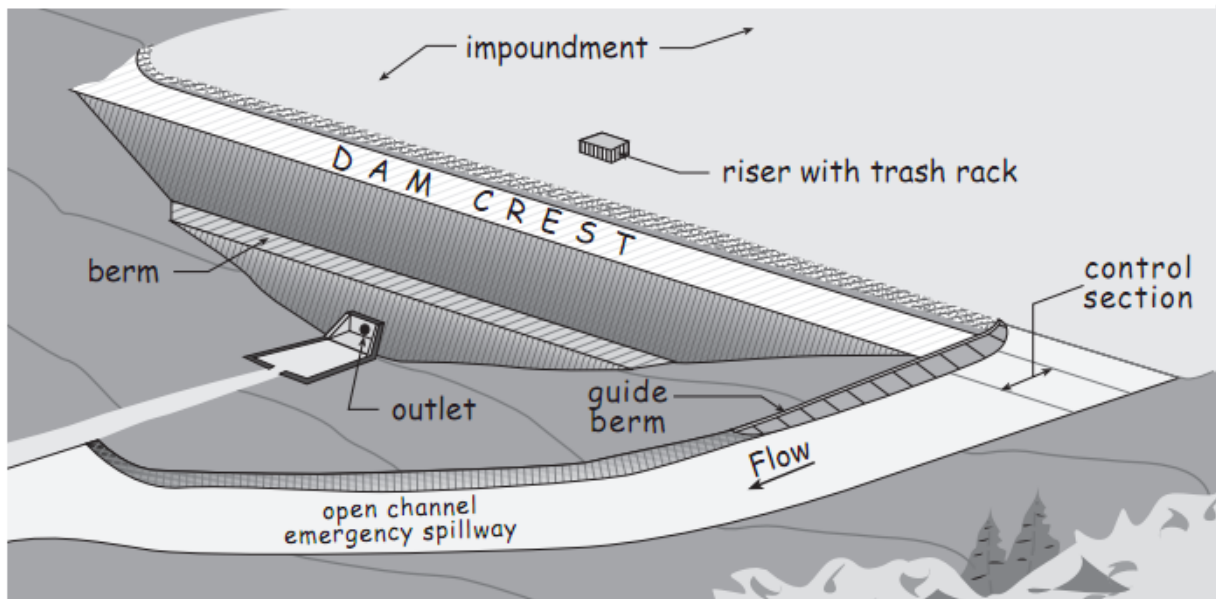
## Overview of an Open Channel Spillway

Erosion in the channel must be repaired quickly after it occurs. Erosion can be expected in the spillway channel during high flows, and can also occur as a result of rainfall and runoff, especially in areas of poor grass cover. Terraces or drainage channels may be necessary in large spillway channels where large amounts of rainfall and runoff

may concentrate and have high velocities.

Erosion of the side slopes may deposit material in the spillway channel, especially where the side slopes meet the channel bottom. In small spillways, this can significantly reduce the discharge capacity. This condition often occurs immediately after construction before vegetation becomes established. In these cases, it may be necessary to reshape the channel to provide the necessary capacity.

Flow through an emergency spillway does not indicate a problem with the dam, but high velocity flows can cause severe erosion and result in a permanently lowered lake level if not repaired. Proper design of an open channel spillway will include provisions for minimizing any potential erosion. One way to minimize erosion is to design a flatter channel slope to reduce the velocity of the flow. Earthen channels can be protected by a good grass cover, an appropriately designed rock cover, concrete or various types of erosion control matting or rock grade control structures. Rock-lined channels must have adequately sized riprap to resist displacement and contain an appropriate geotextile fabric or granular filter beneath the rock. Guide berms are often required to divert flow through open channels away from the dam to prevent erosion of the embankment fill. If an open channel is used for a principal spillway, it

must be rock-lined or cut in rock due to more frequent or constant flows. All dams should have an emergency spillway that will pass high flows without damage to the dam structure. Sizing of the spillway should be done by a professional engineer.
